# **Debris/Ice/TPS Assessment and Integrated Photographic Analysis of Shuttle Mission STS-96**

**DEBRIS/ICE/TPS ASSESSMENT  
AND  
INTEGRATED PHOTOGRAPHIC ANALYSIS  
OF  
SHUTTLE MISSION STS-96**

**27 May 1999**

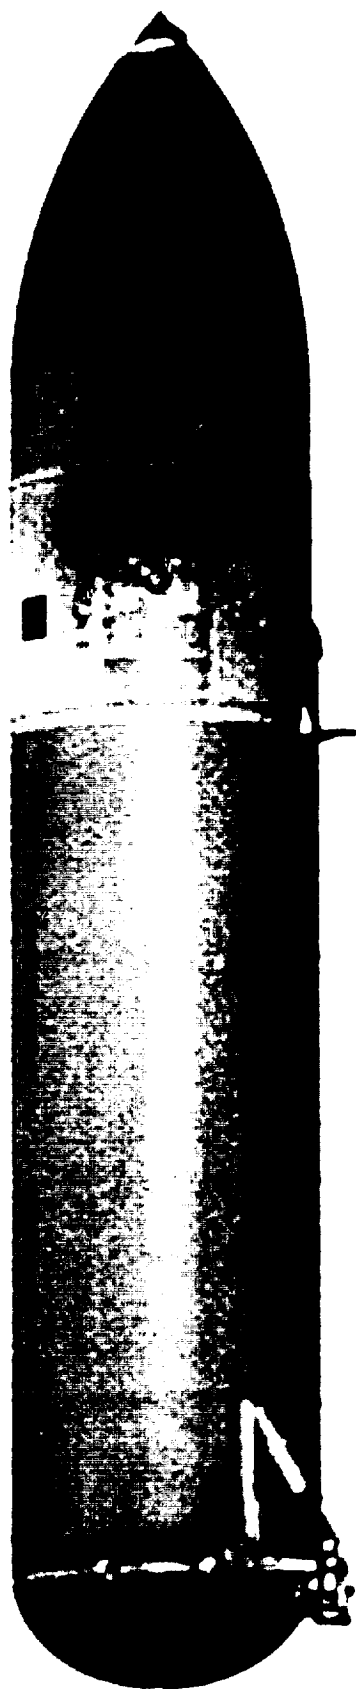
**Photo 21: ET -Y and +Y Thrust Panels**

Due to distance and graininess of the film, small divots and "popcorning" could not be discerned. Note rough texture of upper ogive TPS near nose cone due to foam erosion though the presence of divots could not be confirmed.

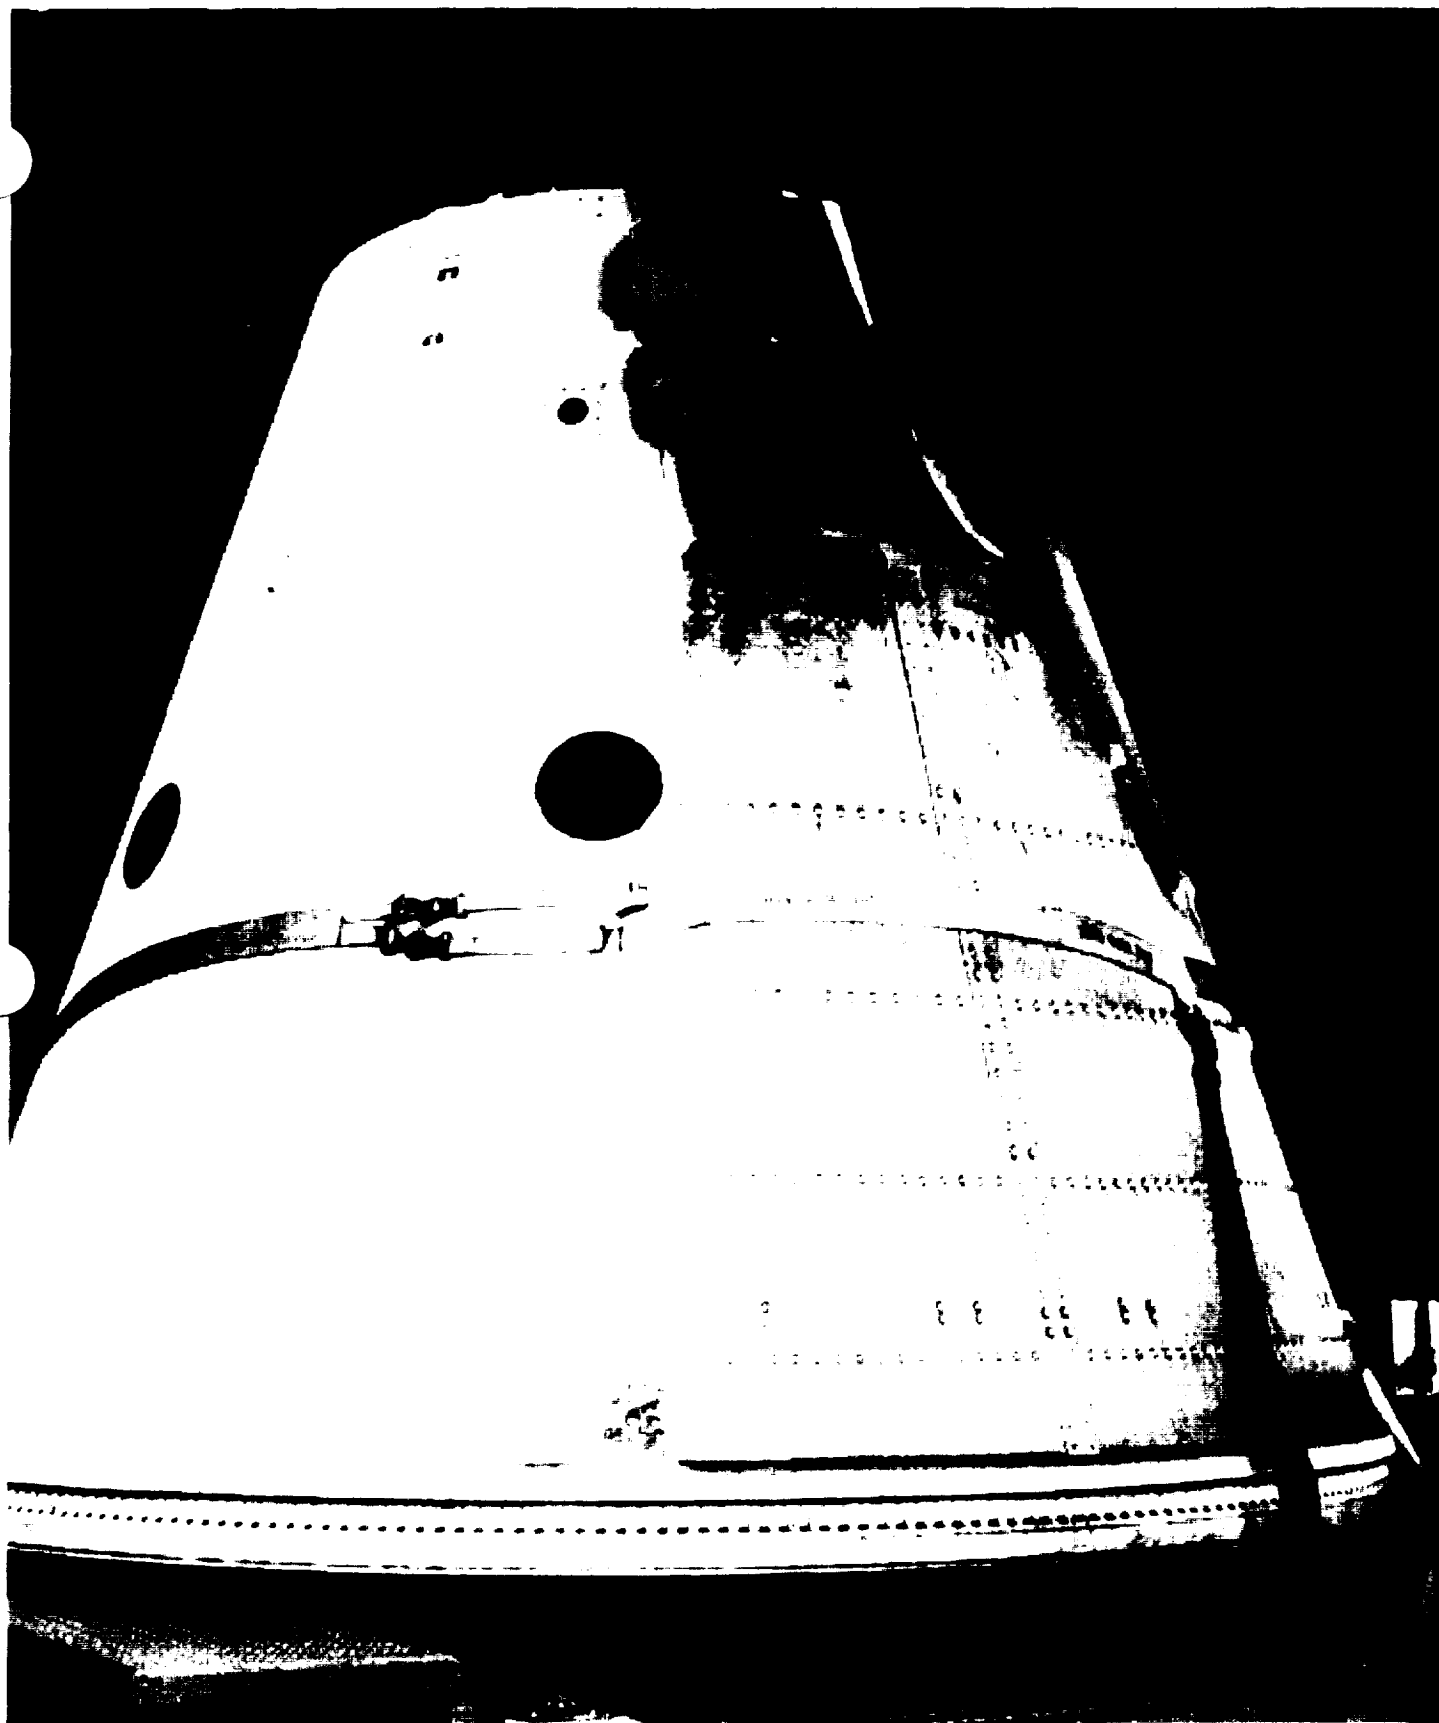
**Photo 24: Frustum Post Flight Condition**

Both frustums were in excellent condition. No TPS was missing and no debonds/unbonds were detected over fasteners or acreage. All BSM aero heat shield covers had locked in the fully opened position.

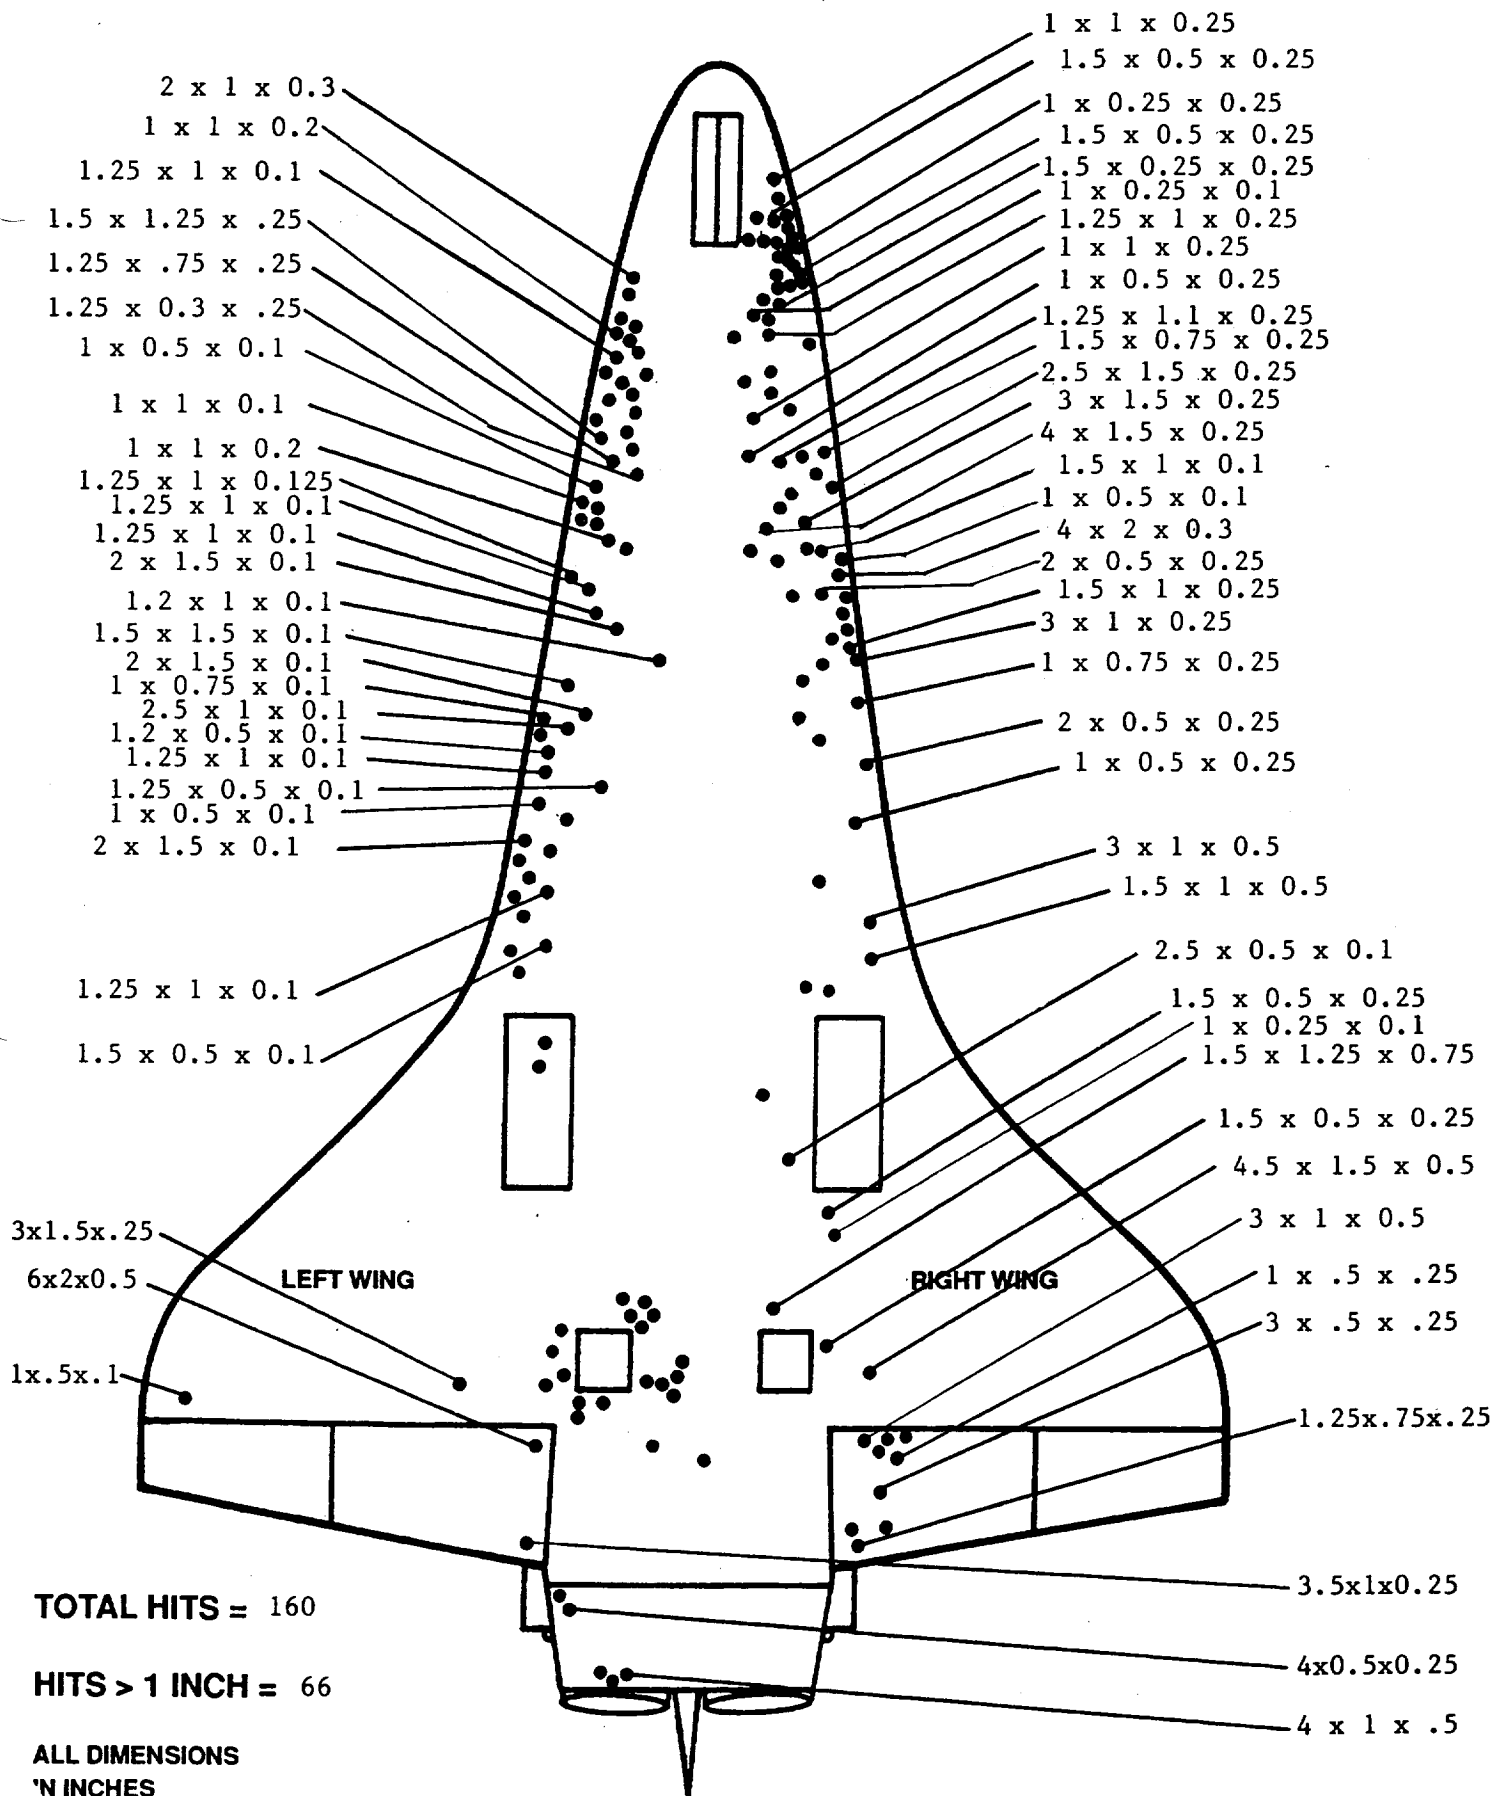
Figure 1: Orbiter Lower Surface Debris Damage Map

The Orbiter lower surface sustained 160 total hits, of which 66 had a major dimension of 1-inch or larger. Most of this damage was concentrated from the nose gear to the main landing gear wheel wells on both left and right chines. The outboard damage sites on the chines followed a similar location/damage pattern documented on STS-86, -87, -89, -90, -91, -95, and -88.

The largest lower surface tile damage site, located on the left inboard elevon, measured 6-inches long by 2-inches wide by 0.5-inches deep. The deepest lower surface tile damage site measured 0.75-inches and was located near the LO2 ET/ORB umbilical.
